Projekt „Rozvoj příhraniční spolupráce vysokých škol v oblasti historické architektury“

STATIC ANALYSIS OF HANGING TRUSS OF BEAMED FLOOR IN EVANGELICAL CHURCH IN VYSNA BOCA

Ing. Renáta Korenková, PhD., Ing. arch. Peter Krušínský, PhD.

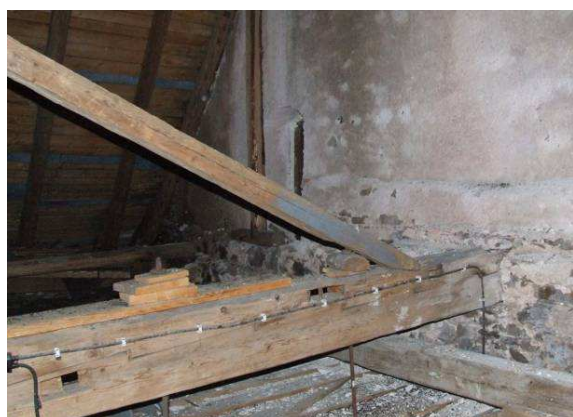
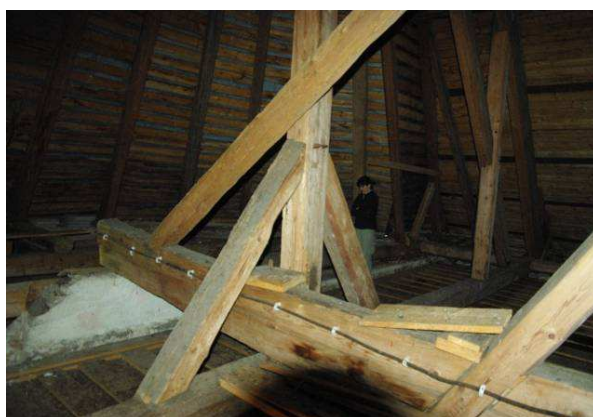
Fig. 7 Left girder anchor beam to the tower walls, right the girder placed on the wall with a visible deflection and tilt to one side.

(Fig. 4). The beam is supported on one side by placed in the towers walls and on the other side it is placed on the wall separating the nave from the sacristy. The beam is at the point of laying on the wall deflected to the side (Fig. 5). The total deflection of the beam is large, visible to the naked eye, about 300 mm.

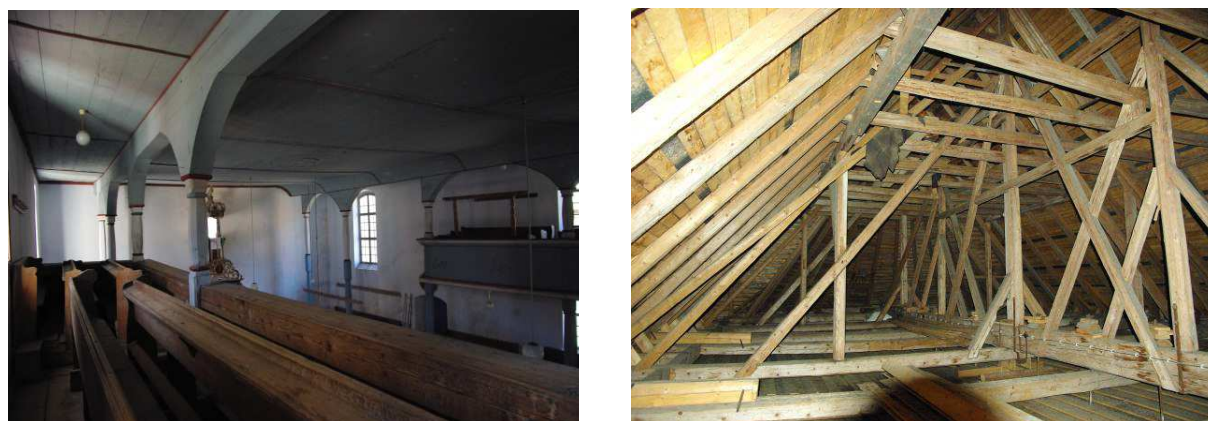
Fig. 6 Visible deflection of ceiling, right view into the under roof space (hanging truss)

Ceiling above the nave is made up of wooden beams of dimensions 240/210 mm. The wooden beams are coated by spruce wood boards from the interior and from under the roof space. Ceiling beams are stuck in the walls. At present, the wooden beams are also supported at the outer sixth of the span. The total light beam span is 13.28 m. The support is a wooden purlin (girder) 2.05 m from the perimeter. Deflection of the lower edge of the ceiling is visible to the naked eye. (Fig. 6)

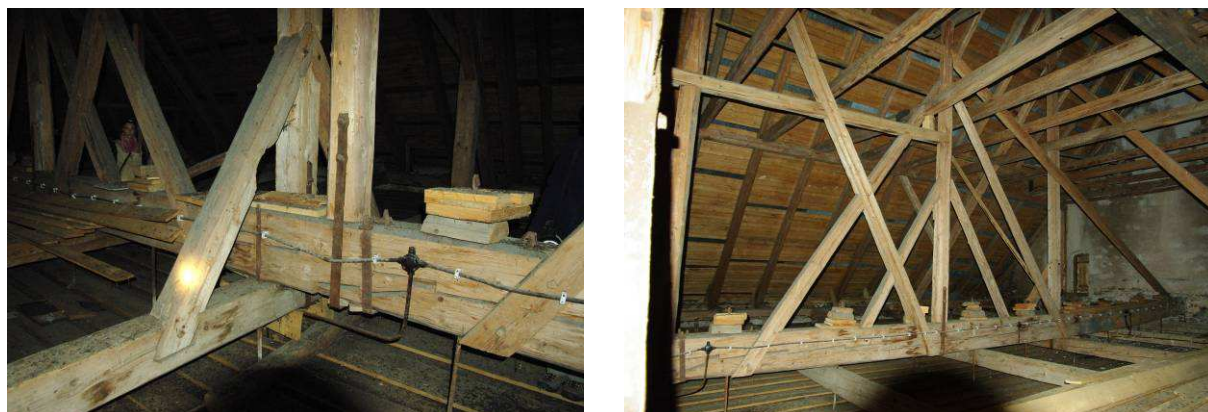
Fig. 8 Left - joint the king-post with a beam grill and extension the lower beam of girder grillage.
Right - view to the truss-post ceiling.
