Projekt „Rozvoj příhraniční spolupráce vysokých škol v oblasti historické architektury“

THE ANALYSIS OF METHODS USED IN RENOVATION OF HISTORICAL ROOF FRAMES

ANALÝZA POUŽÍVANÝCH SANAČNÝCH METÓD PRI OPRAVÁCH HISTORICKÝCH KROVOV

Ing. Renáta Korenková, PhD.

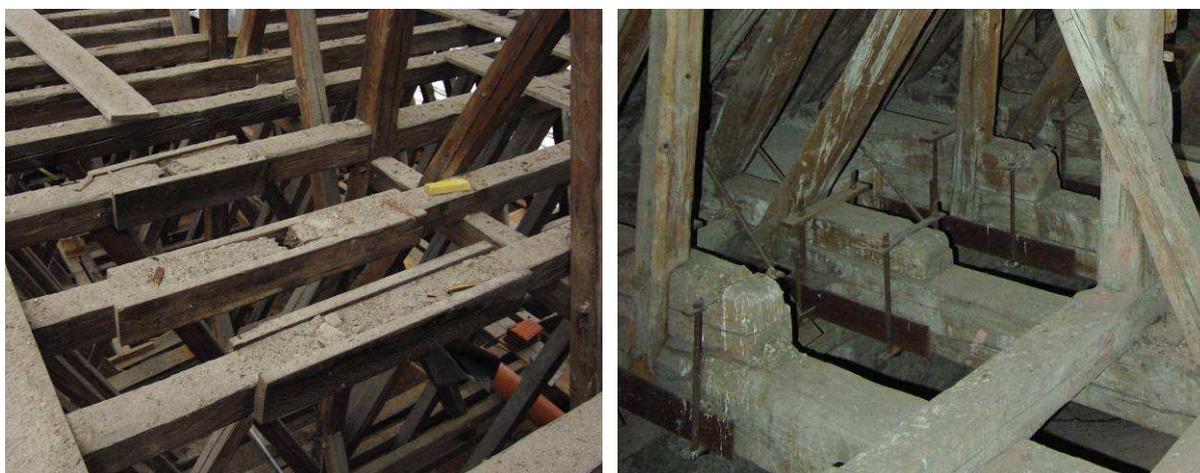
Fig. 1. Left - double-sided fishing in the church truss in Okoličné.

Right - an example of anchoring tie beams using steel consoles in the Blatná's castle (the Czech Republic).

Obr. 1 Vľavo obojstranné príložky v krove nad kostolom v Okoličnom, vpravo príklad kotvenia väzných trávov do ocelových konzol, hrad Blatná (ČR)

A. Fishing - right to reinforce damaged parts, and those that have not sufficient load capacity as for the present, or the future situation. Fishplates made of heavy wood, wood substances, steel, and other materials are put into effect e.g. in repairing beam or rafter

C. Anchoring, i.e. inserting sound part of a member into a steel console - applied in particular situations, e.g. strengthening beam heads that are markedly damaged. Anchoring can be made in a traditional manner, or with special stainless monolithic consoles. It is rarely employed in our country.

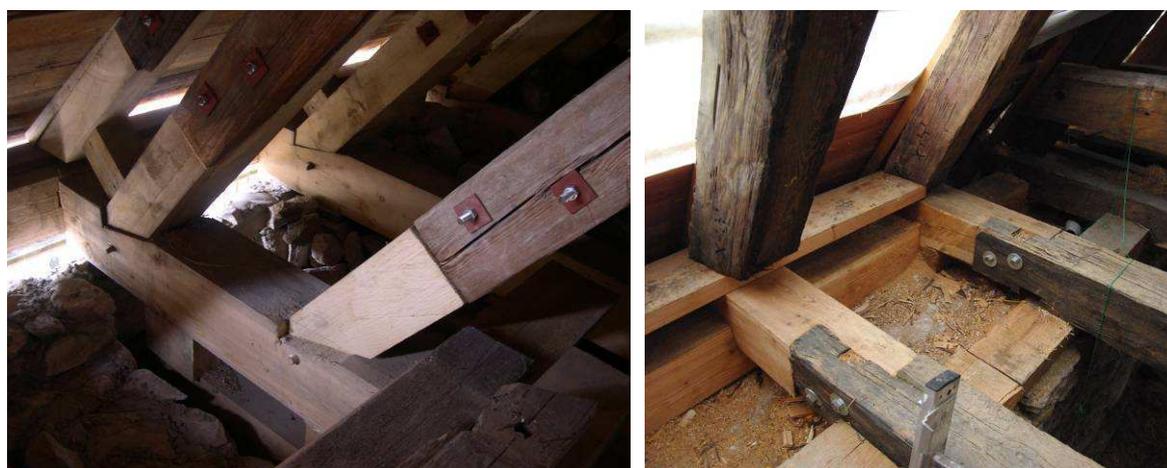
Fig. 2. Left - the repair of a tie beam together with rafter heels and struts. Photo shows new parts, dressed to fit for dimensions of original ones, in the St. Jacob's Church in Horní Slavkov (the Czech Republic). Right - the repair of tie beam heads with prostheses, an exchange of wall plates in the church truss in Okoličné.

Obr. 2 Vľavo Oprava väzného trámu, spolu s päťami krokiev a podkrokvových vzpier. Nové prvky sú hobľované, tvarovo prispôsobené rozmerom pôvodných prvkov. Horní Slavkov – Kostol sv. Jakuba staršieho (ČR). Vpravo Okoličné, oprava zhlavia vzných trámov protézami, výmena pomúrnic.

A. Using prostheses - a broken part is replaced, or completed with a new one (prosthesis). This is accomplished either by classic, or beta method. Carpenter's techniques are required to be preferred in historically valuable buildings. It is the most used way of repairing. In terms of the conservation, it is tolerable until connective parts are related, and newly inserted wood is of the same species and treatment.

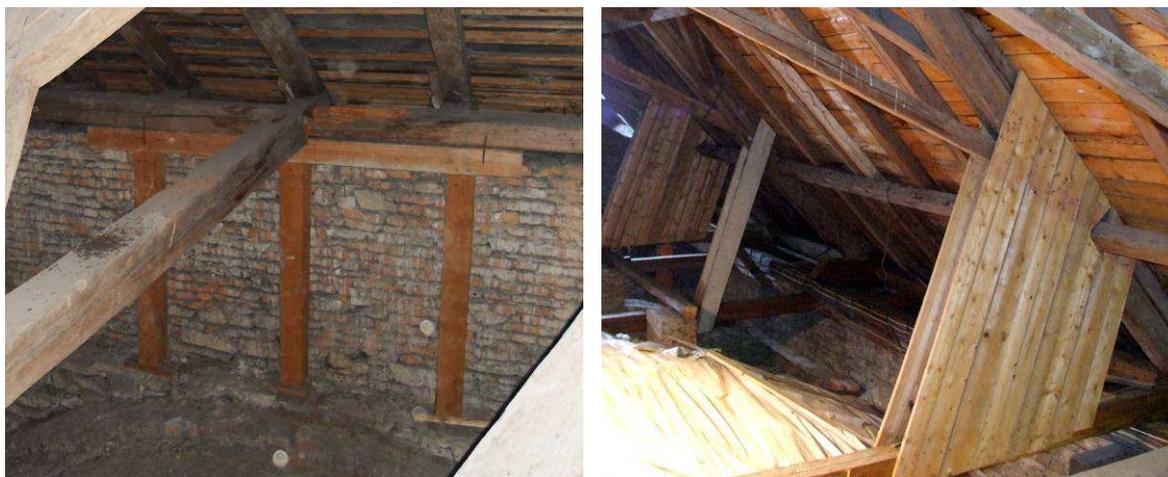
Fig. 3. Left - supporting, Kysucké Nové Mesto. Right - bracing, Liesek.
Obr. 3 Vľavo Kysucké Nové Mesto, podopretie. Vpravo Liesek, stuženie

V. Supporting - used when implementing temporary as well as long-term repairs of horizontal, and some diagonal members. It is a frequent, very often provisional solution

VI. Bracing - regarding trusses, this is, along with toughening unbound parts of a spacial construction, the most employed technique. Its application is common, it have to be realized in accordance with structural engineer's instructions, and conservationist's requirements as well.

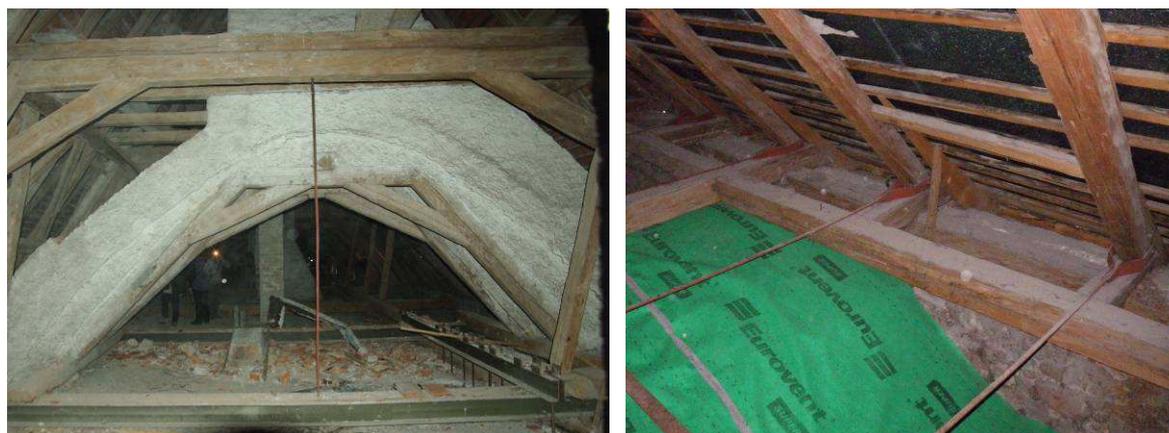
Fig. 4. Left - the steel construction used for construction of an object and unloading of a ceiling in the manor house in Moravský Krumlov. Right - bidirectional bracing of a truss using steel tie bars, Kvačany.

Obr. 4 Vľavo kaštieľ - Moravský Krumlov – vložená oceľová konštrukcia na stiahnutie objektu a odľahčenie stropu. Vpravo stiahnutie krovu oceľovou pásovinou v oboch smeroch. Kvačany

VIII. Other methods - e.g. inserting of some members, constriction of constructional wholes, or the transfer of preload onto a construction. It is often applied due to the problematic transfer of horizontal load in historical trusses.

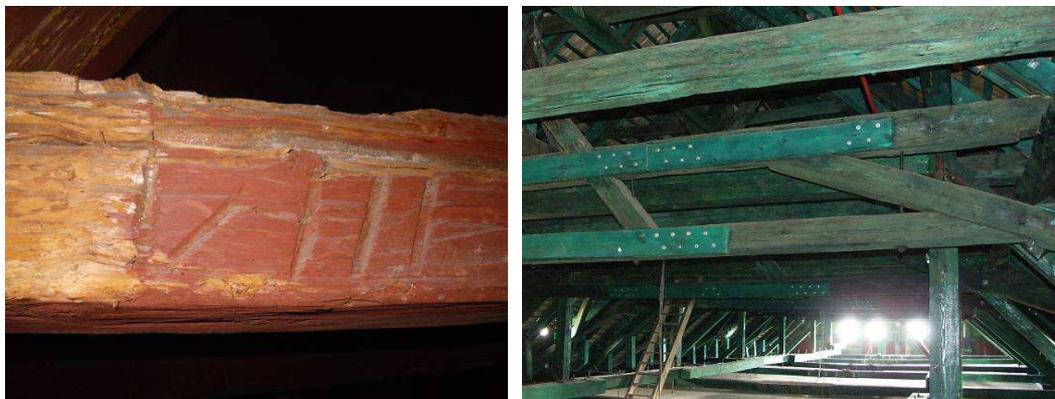
Fig. 5. Left - the removal of a surface layer from the timber member damaged by ligniperdous insects (degradation of a carpenter's mark) in the St. Martin's Cathedral in Bratislava.

Right - the restoration using fishplates finished with dark-green protective coating in the wooden, so-called Peace Church, dated from the middle of the 17th century in Jawor, Silesia (Photo by L. Suchý).

Obr. 5 Vľavo zosekanie povrchovej vrstvy dreveného prvku poškodenej drevokazným hmyzom (znehodnotenie tesárskej značky) – katedrála sv. Martina v Bratislave. Vpravo Sliezko, Jawor (drevený tzv. mierový kostol) z polovice 17. storočia sanačná obnova príložkami „zavřená“ farebným tmavozeleným ochranným náterom – foto LŠ.

IX. The treatment of the damaged surface of a timber element resulting in lessening the section without breaking a minimal bearing section - it is consider to be unsuitable by conservationists, because both traceological prints and a historical value can be degraded when removing a surface layer [6].
